Property Address: 28109 WALLER GLADISH RD

Report Identification: 28109 WALLER GLADISH RD

Tucker Inspections LLC

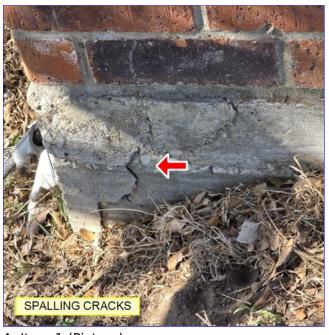
A. Item 1 (Picture)

Spalling cracks were noted at the corners. This type of cracking is common and does not compromise the integrity of the foundation.

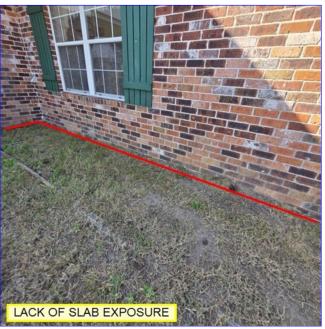
B. Item 1 (Picture)

The soil is high along areas of the foundation. It is recommended that at least three to four inches of slab is visible above the height of the grass or flower beds. Lack of slab exposure can lead to water and insect problems.

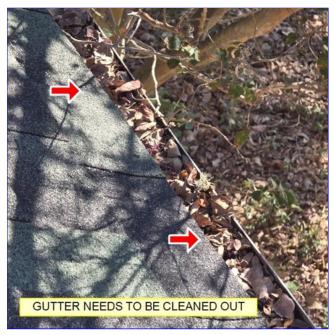
B. Item 4 (Picture)

The gutters need to be cleaned out.

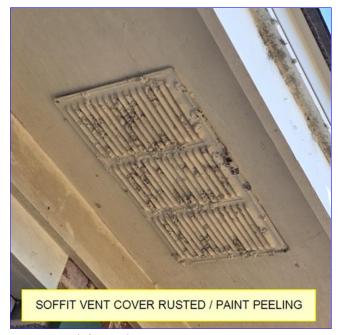
C. Item 2 (Picture)

Several soffit vent covers were rusted / have peeling paint.

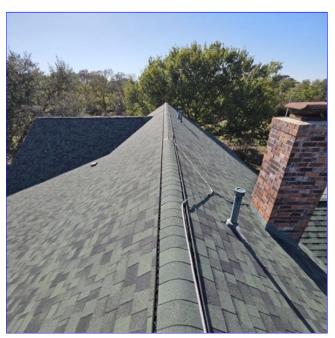
E. Item 1 (Picture)

The tree branches should be trimmed away from the roof to help prevent damage to the shingles.

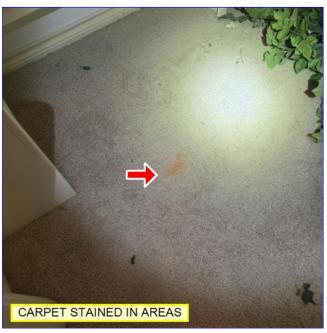
F. Item 1 (Picture)

The carpet was stained / dirty in areas

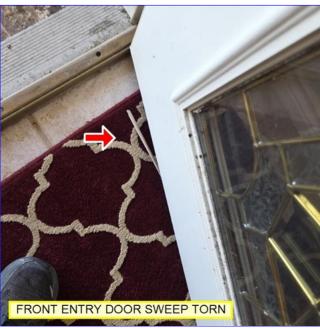
G. Item 1 (Picture)

The front entry door was rusted.

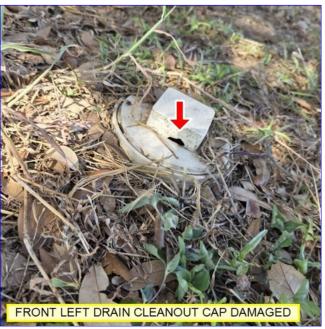
B. Item 1 (Picture)

The front yard left drain clean out cap was damaged. Recommend replacing the cap.

The front left hall bathroom shower pan appears to have been cracked in two areas and sealed. I plugged this drain and let water sit in the pan at over 1 inch for roughly 15 minutes. I did not observe any visual signs of leakage and the pan held water.

Recommend sealing the gaps between the front left hall bathroom shower walls and pan to help prevent moisture penetration.

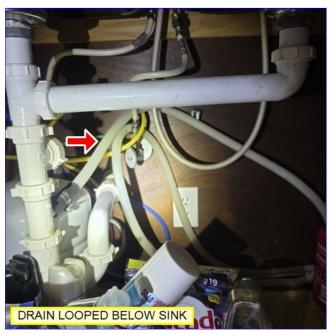
A. Item 1 (Picture)

The dishwasher drain line is below the sink drain.

Current building standards require the dishwasher drain to be above the sink drain. This prevents the sink from draining back into the dishwasher drain line. Simple repair: just secure the drain line above the sink.

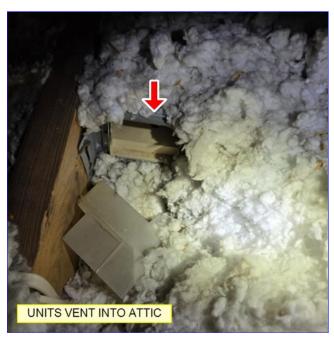
F. Item 1 (Picture)

The front right bathroom vent fan cover was loose from the ceiling.

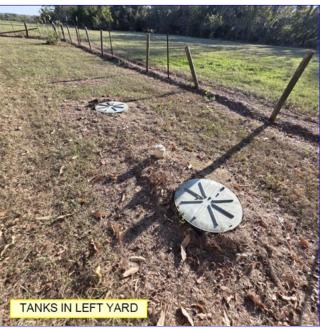
A. Item 1 (Picture)

The front tank lid was damaged. Recommend replacing the tank lid.
