Property Address: 28109 WALLER GLADISH RD

Report Identification: 28109 WALLER GLADISH RD

Tucker Inspections LLC

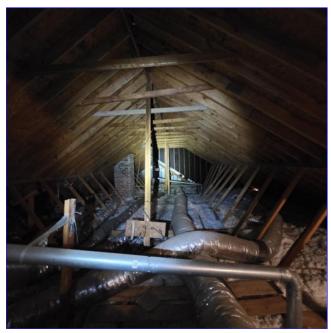
D. Item 1 (Picture)

The insulation has become compacted over the years and no longer meets R30 rating in all areas.

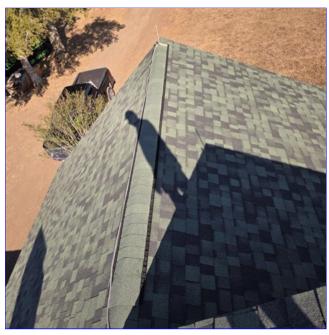
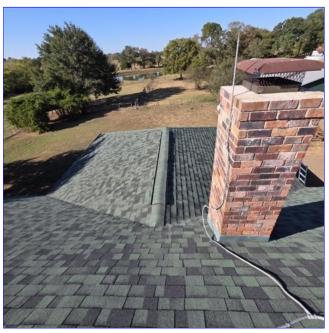
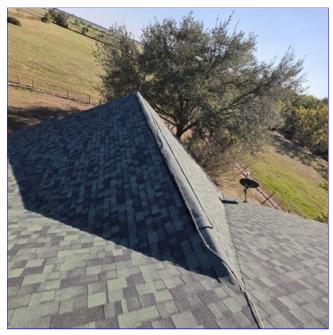
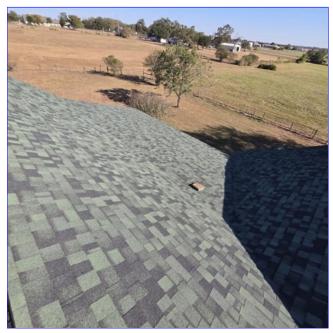
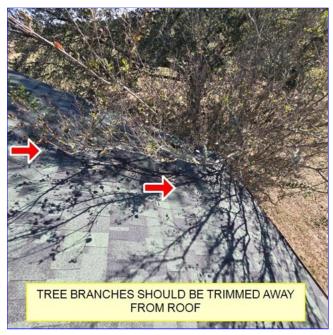
This is a composition shingled roof. No deficiencies found at the time of this inspection.

The tree branches should be trimmed away from the roof to help prevent damage to the shingles.

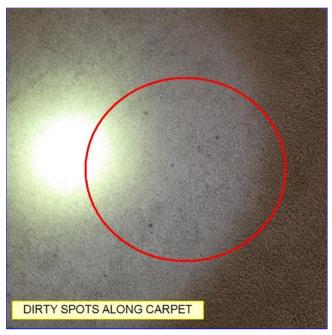
F. Item 2 (Picture)

The carpet was stained / dirty in areas

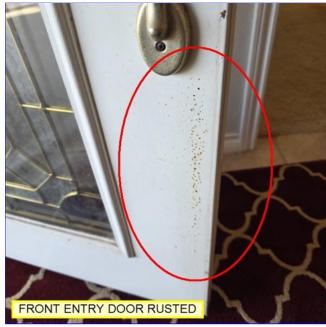
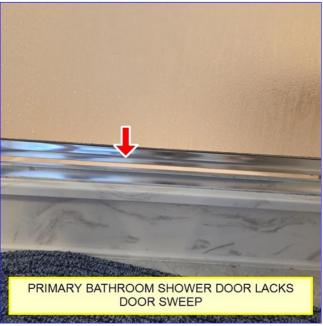
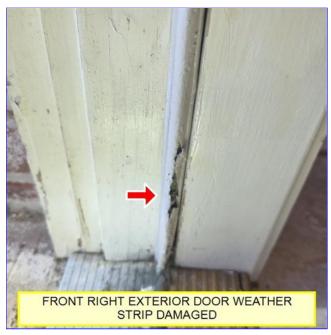
The front entry door was rusted.

The front right exterior door weather strip was damaged.

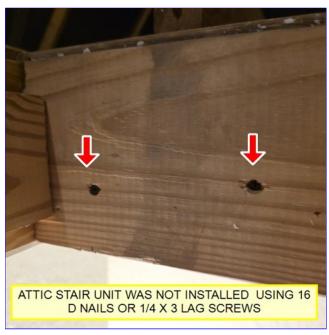
I. Item 1 (Picture)

The attic stair unit was not installed using 16D nails or $1/4 \times 3$ " lag screws. This does not meet factory installation requirements.

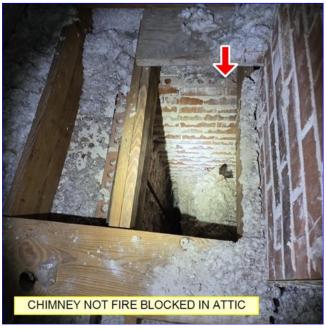
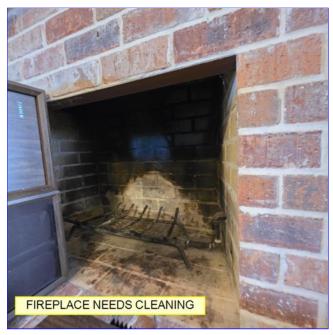
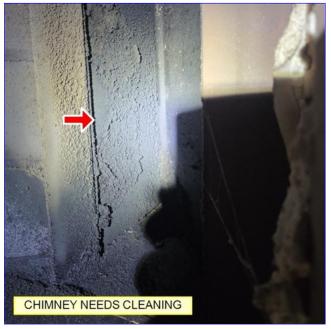
The fireplace and chimney need to be cleaned.

The chimney is not fire blocked in the attic. This would not meet current building standards.

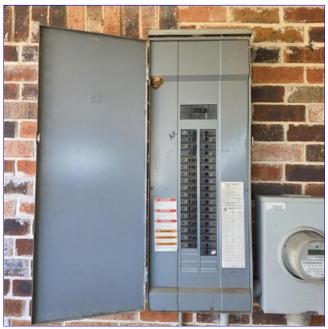
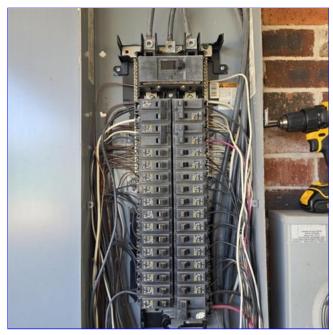
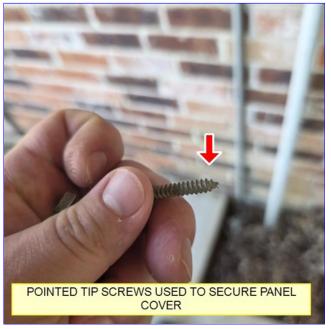
There was not a surge protector present in the electrical panel. This would not meet current building standards.

The panel cover screws were pointed tip. Current building standards requires flat tipped screws for electric panel covers.

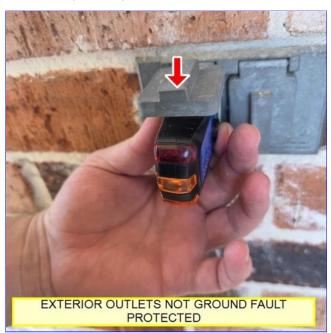
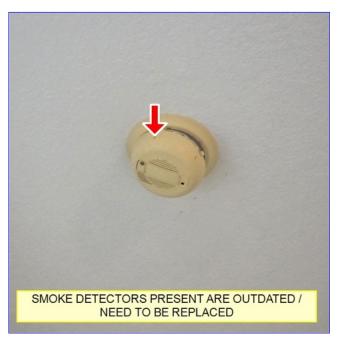
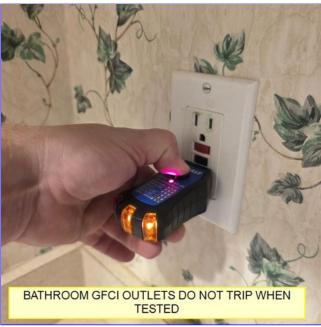
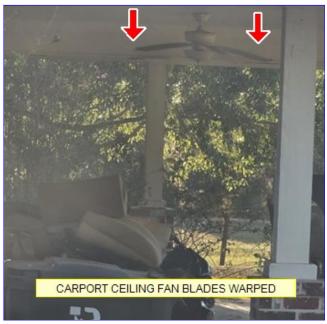
The front porch ceiling light fixtures trim was rusted.

GFCI outlets were present in the bathrooms but but do not all trip when tested. GFCI outlets have a service life span. Recommend replacing GFCI outlets in these areas.

Not all of the bedrooms had a smoke detector present. *Recommend installing detectors for safety.*

The smoke detectors that are present in the home were outdated and need to be replaced. Current building standards requires a smoke detector inside and outside of bedroom sleeping areas.

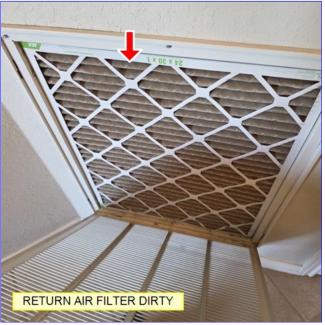
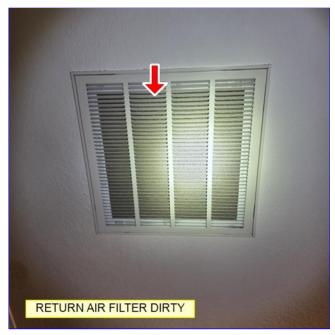
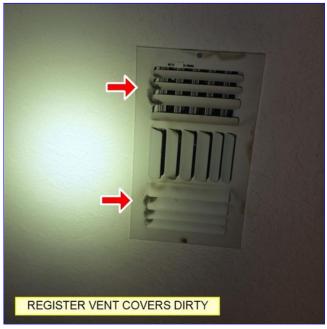
The filters were dirty and need replacing.

Several of the register vent covers in the home need to be cleaned.

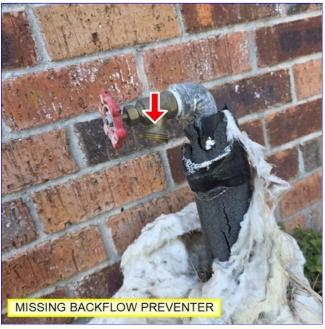
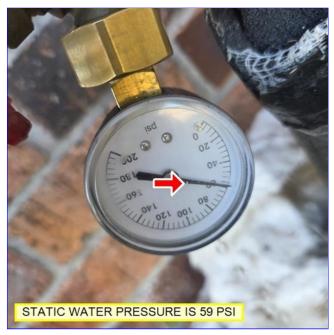
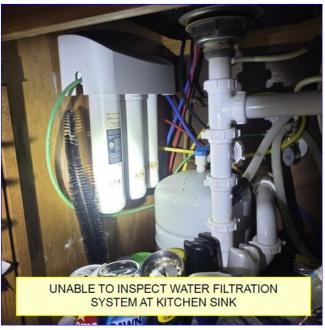
There were missing back flow preventer on the exterior hose bibs.

Backflow preventers are small check valves that screw onto the ends of the exterior hose bibs. They prevent water from reversing flow back into the water lines if the city loses water pressure. These are required by City and State Standards.

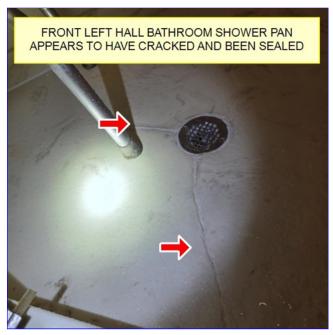
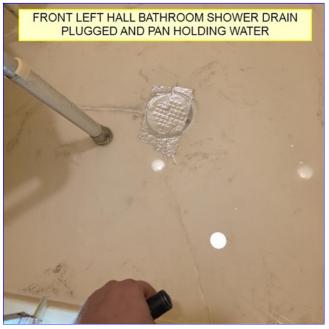
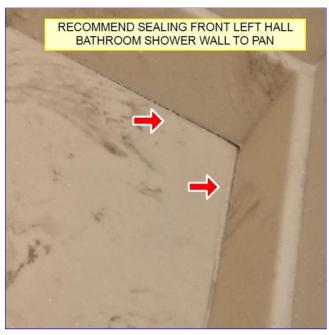
The front yard left drain clean out cap was damaged. Recommend replacing the cap.

The front left hall bathroom shower pan appears to have been cracked in two areas and sealed. I plugged this drain and let water sit in the pan at over 1 inch for roughly 15 minutes. I did not observe any visual signs of leakage and the pan held water.

Recommend sealing the gaps between the front left hall bathroom shower walls and pan to help prevent moisture penetration.

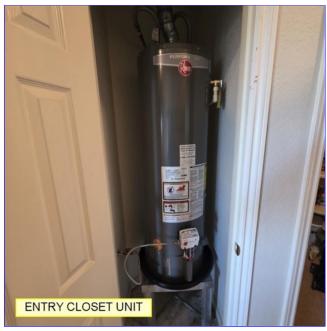
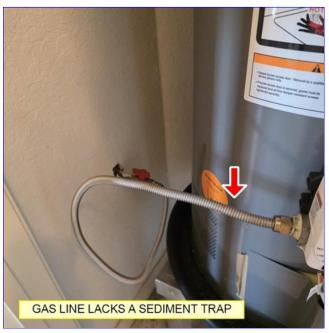
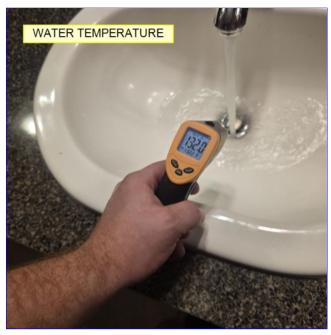
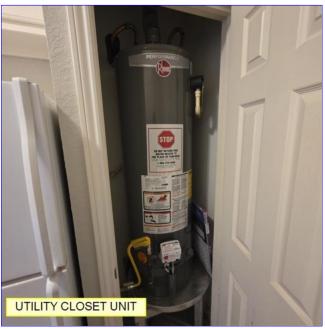
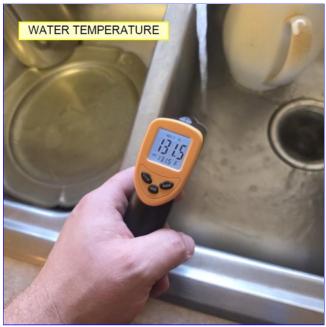
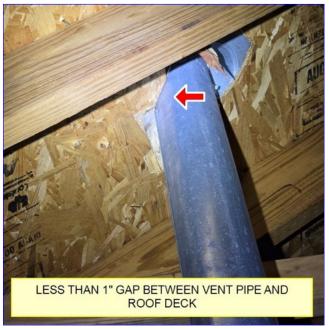
Both units were located in closets that lack adequate ventilation. These are propane fueled appliances that need adequate combustible air. *Recommend adding sources of ventilation such as through door vents.*

The utility room unit is a propane fueled appliance located in a room adjacent to a sleeping area. *Current building standards would not allow this.*

The entry hall unit lacks a sediment trap on the gas line. This would not meet current building standards.

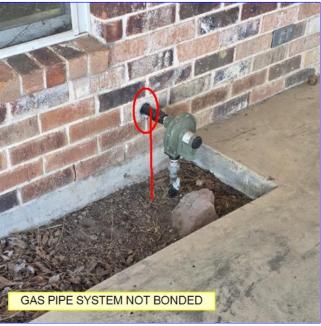
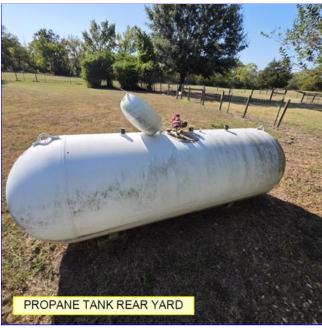
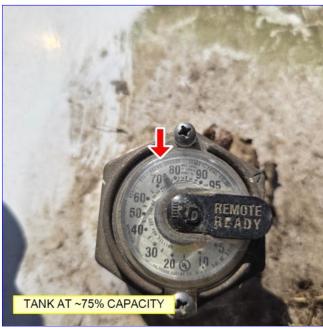
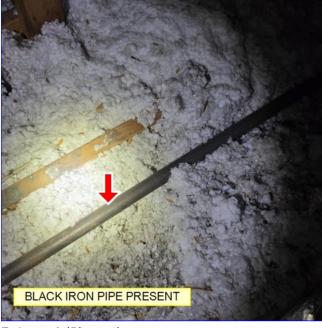
There was black iron pipe present.

The gas pipe system was not bonded. This would not meet current building standards.

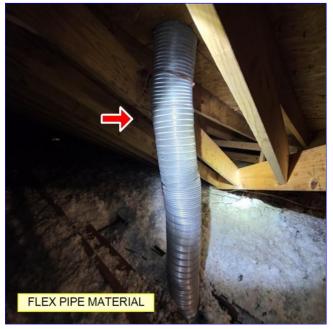
C. Item 1 (Picture)

The vent pipe material is not the correct type pipe. This should be a single wall smooth metal vent pipe.

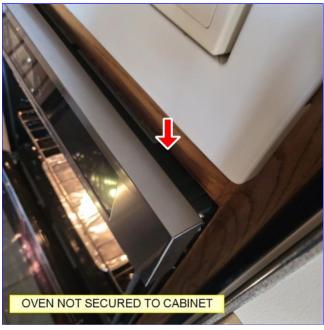
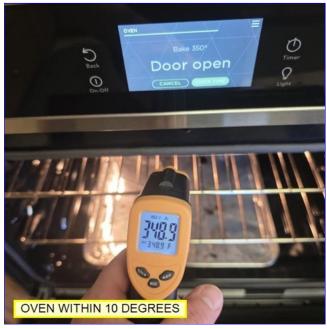
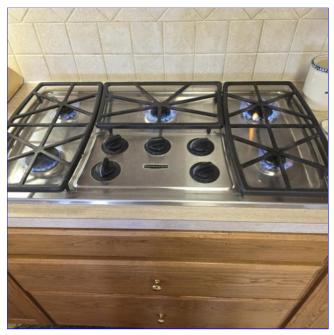
This is a gas cooktop and a built in electric oven. The cooktop and oven were operational at the time of the inspection.

The oven was not secured to the cabinet and moves when force is applied.

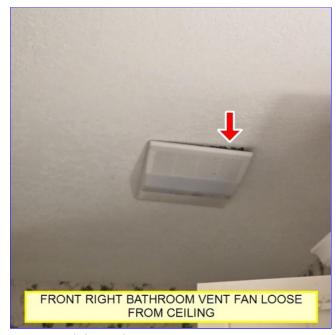
F. Item 2 (Picture)

The front right bathroom vent fan cover was loose from the ceiling.

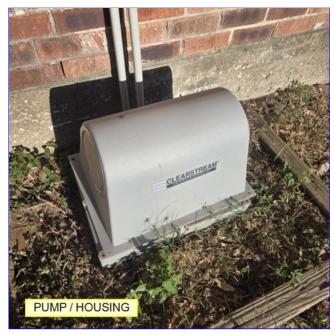
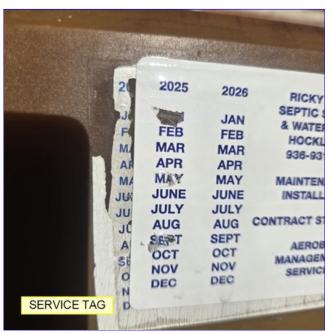
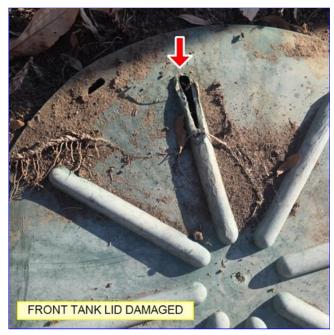
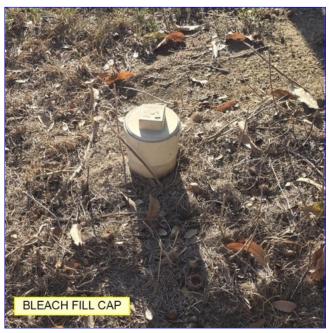
The front tank lid was damaged. Recommend replacing the tank lid.
